# Split Rock Lighthouse

## HISTORICAL RESTORATION CASE STUDY

# NON-ABRASIVE CLEANING PROCESS HELPS STATE LANDMARK SHINE

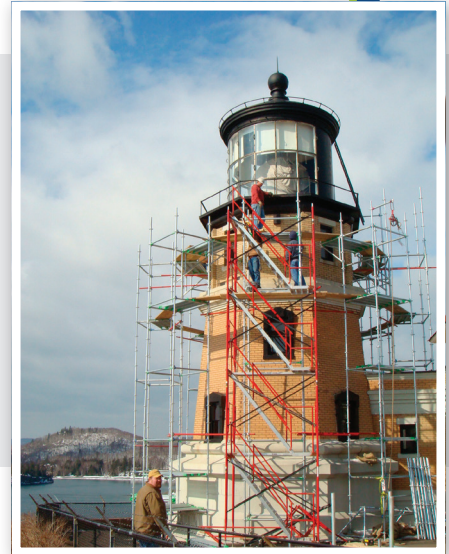
Veit was able to clean around the rare and expensive Fresnel lens, which was covered in soda after the prior preservation project.

to clean the interior and exterior of the lighthouse's lantern room. The Split Rock maintenance crew was able to control the pressure of the blast stream, which ensured that no additional damage was done to the landmark. Veit was able to clean around the rare and expensive Fresnel lens, which was covered in soda after the prior preservation project.
