Benterud School

SURFACE PREPARATION CASE STUDY

CITY OF LØRENSKOG REMOVED PAINT FROM A BRICK/CONCRETE WALL OUTSIDE A SCHOOL IN NORWAY

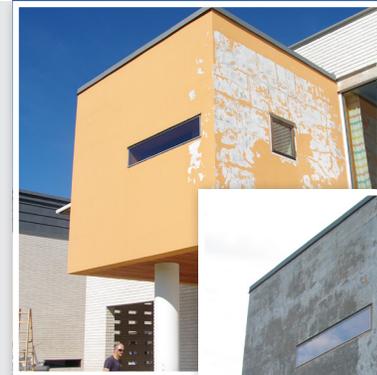
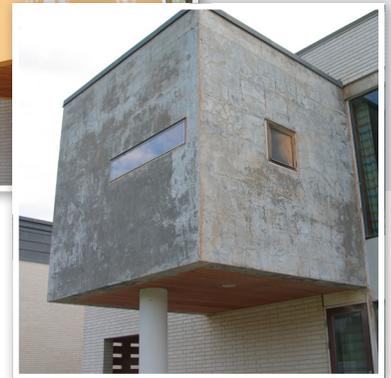
Dry ice cleaning removed the paint, fine layer on bricks, and took out loose surfaces (that is normally done by hand) in one operation

Built in 1999, the primary school had been painted twice in previous years, and was in desperate need of new paint as the last coat was beginning to crack and chip away from the external walls. A decent paint job should last about 10 years, but a surface polish layer on top of the bricks was not allowing the paint to adhere to the surface.

"We explained to the school that with dry ice cleaning, we can remove the paint, the surface polish and any loose surface area underneath," added Andresen. "We would not have to do every wall by hand, and the process would not damage the walls. Dry ice cleaning is also the safest solution for workers and the kindergarten kids and the most environmentally responsible solution because there is no secondary waste. In addition to these benefits, we also explained that the school would not have to paint for at least another 10-15 years." Considering the environmental and safety benefits, as well as the effectiveness of dry ice cleaning, the school contracted with Andresen & Far to complete the project.

After the paint, polish and loose materials were removed from the three worst areas, a bricklayer was brought in to resurface the walls. Once the walls had dried, Andresen and his team applied a new coating of paint. Since the completion of that part of the school, Andresen has been contracted to complete another 400 square meters (4,300 square feet) of the school using the same dry ice cleaning process.
