# Toro Golf Utility Tractor Restoration

## HISTORICAL RESTORATION CASE STUDY

### DRY ICE AND CRUSHED GLASS SUCCESSFULLY USED TO RESTORE 70 YEAR-OLD HISTORIC TRACTOR

Remove years of paint and rust to restore one-of-a-kind Toro General Golf Utility Tractor

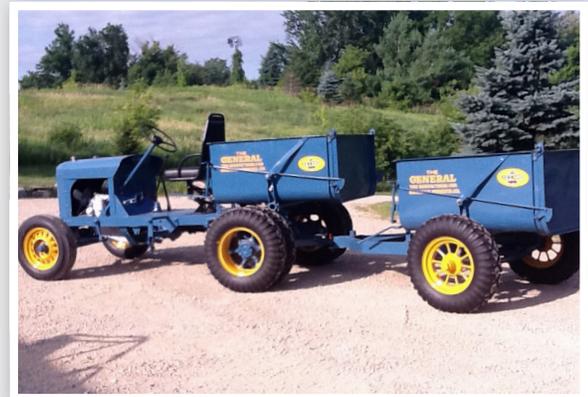
Cleaned 70 years of paint and rust down to bare metal to prep tractor for restoration.

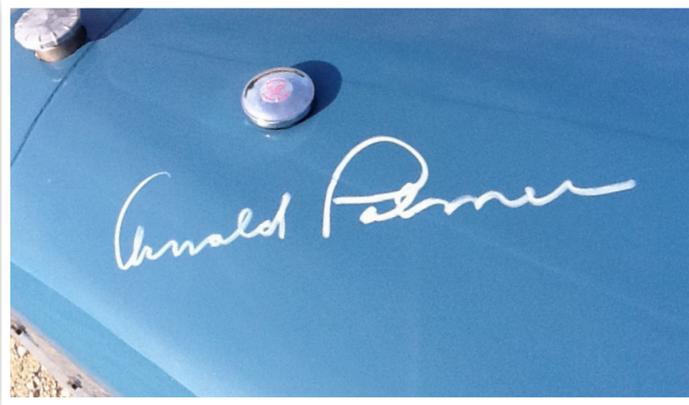
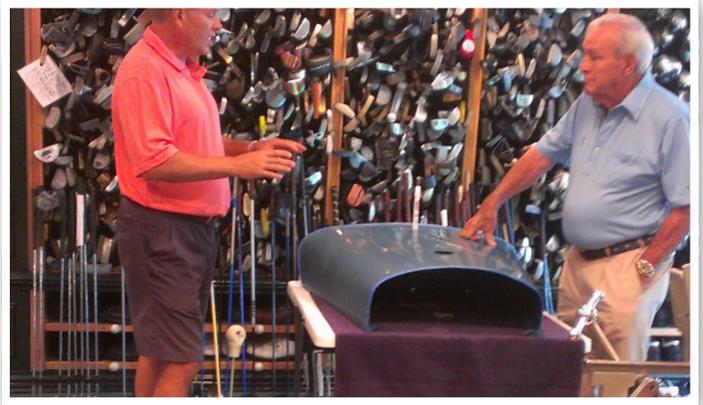
The tractor was in operating condition; however, had acquired a good deal of rust over the years and the surface paint was severely damaged. In order to fully restore the tractor, the paint and rust needed to be removed.

The Farrow system allowed for removal of all layers of rust, paint and primer down to bare metal or a white metal finish, leaving behind a surface ready for repainting. A chemical was also added to preserve the parts and prevent flash rust. The profile would now easily accept the new primer and the process was faster than dry abrasives, without creating dust or requiring extensive cleanup.

Next, Cold Jet's Aero 80 HP was used as a surface preparation method to clean the oil and grime off areas where the wet abrasive media could not get into – such as the transmission, pushings, bearings and wheel hubs. Cleaning the intricate, hard to reach parts with Cold Jet's dry ice cleaning technology was the perfect solution because it used non-abrasive media in the form of recycled CO<sub>2</sub> pellets that will not damage surfaces. The combination of dry ice cleaning's kinetic energy and thermal effect breaks the connection between the dirt and surface, lifting away contaminants. Unlike blasting with other media, dry ice cleaning does not leave any secondary waste, because the dry ice particles sublime on impact – converting from a solid to a gas. Dry ice cleaning is safe, non-toxic, does not create downstream contamination and eliminates exposure to dangerous chemical cleaning agents.
